H3C Comware 7 IRFを構成している機器の交換方法について

New h3c Technologies Co.,Ltd.

6W103-20200507

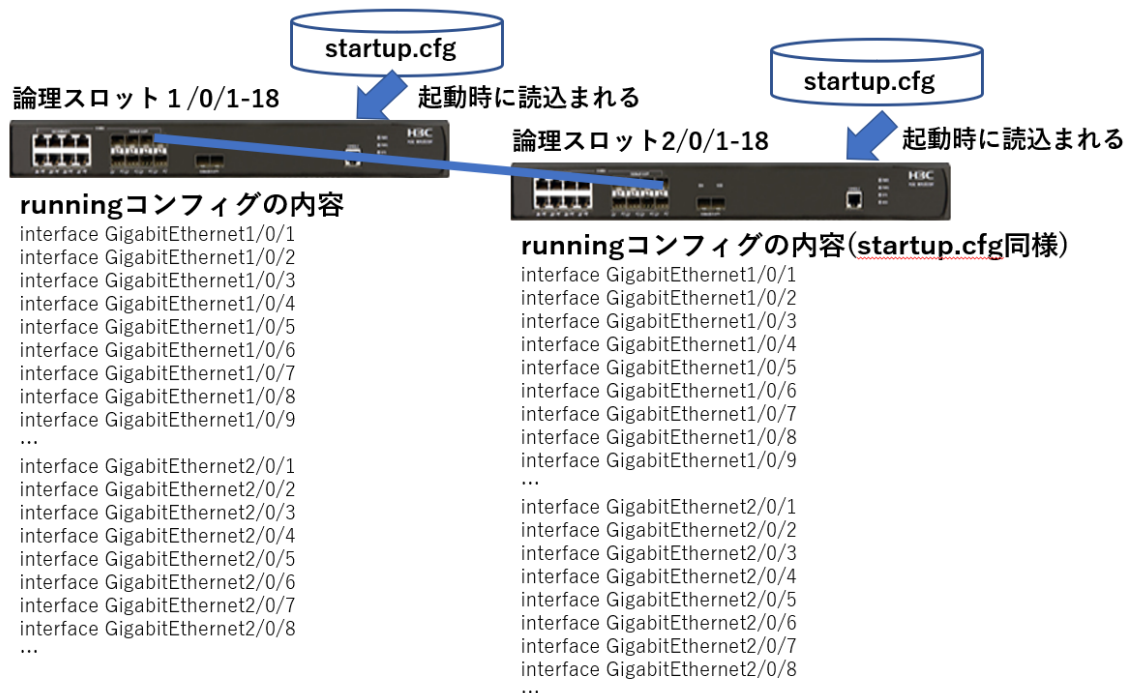
例えば、構成されているポートの情報を表示すると全ての論理スロットに存在するポートの情報が `gigabitEthernet 1/0/1,gigabitEthernet 2/0/1` のようにスロット番号がそれぞれのポート番号の前のスロット番号に反映されております。

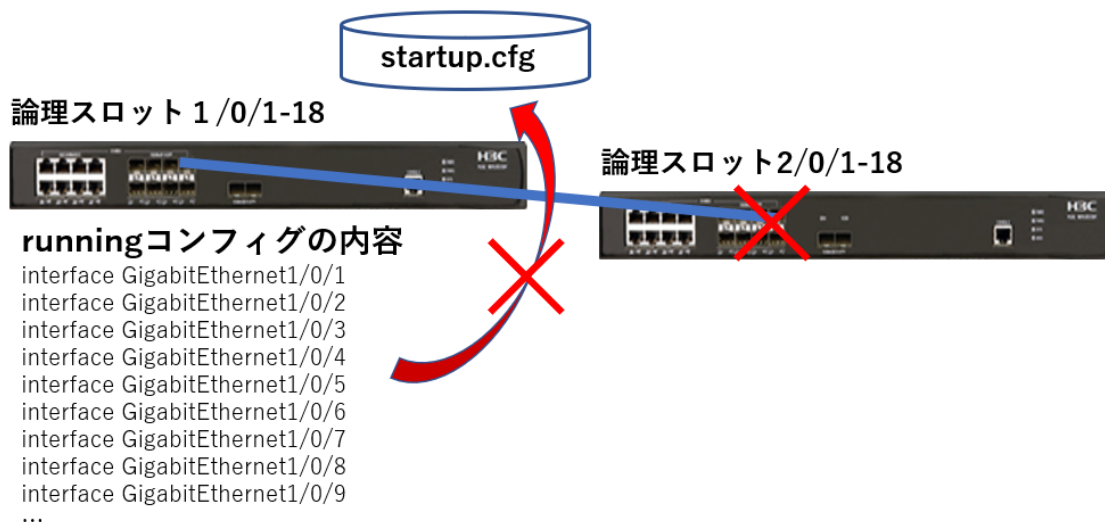
しかし、どれかのスイッチやルーターに障害が発生した場合、running コンフィグから障害の発生した装置のポート情報は現れなくなります。

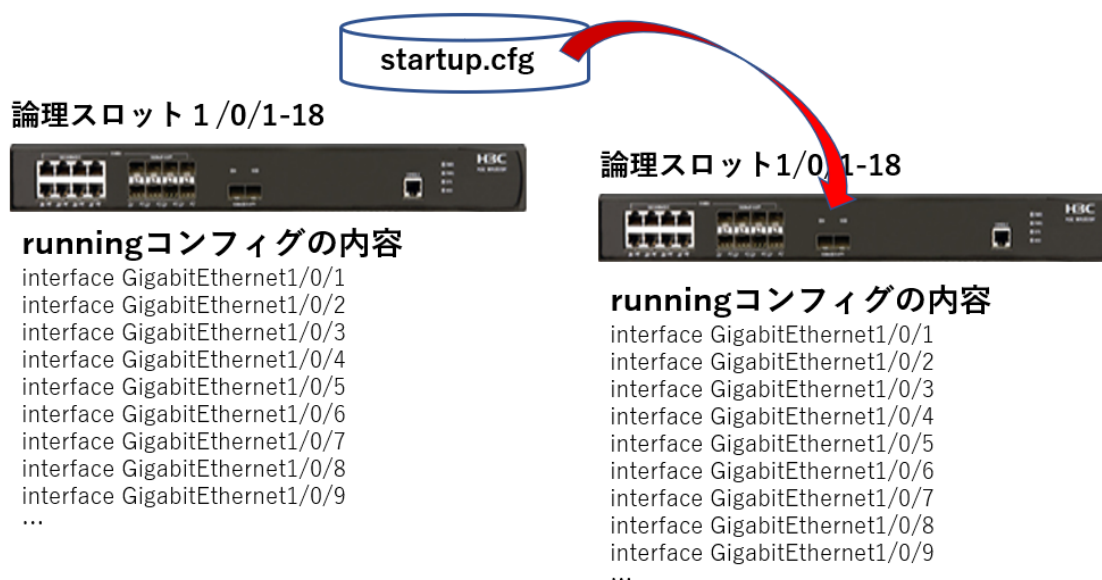
従って、例えば論理スロット2の装置を交換する場合には、startup.cfg を flash ドライブにコピーしても起動すると、この機器のポートの論理スロットは1と認識されてしまいます。

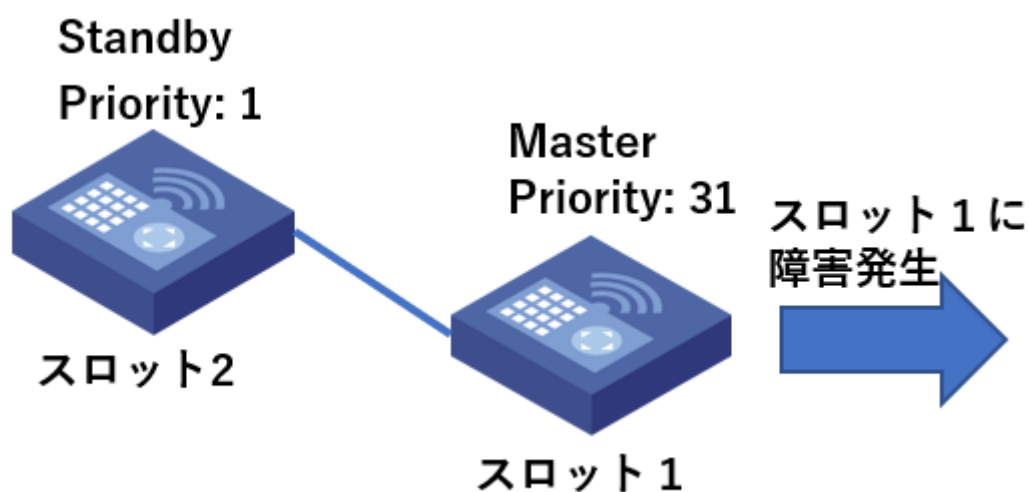
以下はスプリットされた IRF ファブリックがマージされる場合を図式化しました。

スプリットされた IRF ファブリックがマージ(復旧)された場合、マスター選択は行われませんので、マスターはマスターのままとなります。

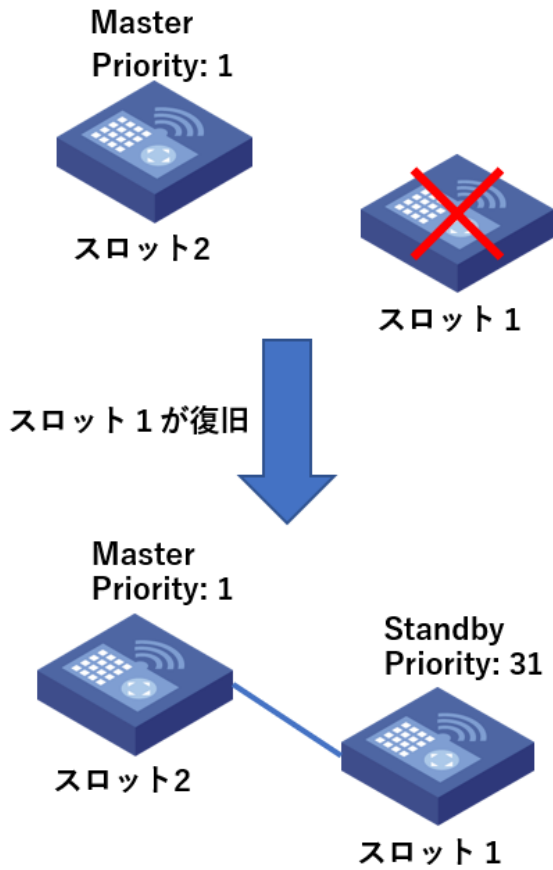
```
<IRF>dis irf
MemberID  Role  Priority CPU-Mac
Description
*+2      Master  1      f010-90db-7403 --
-----
* indicates the device is the master.
+ indicates the device through which the user
logs in.
